**FINAL REPORT:**  
**CAMPAMENTO SHALOM**  
**MAY 13, 2005**  
**ENGINEERING 340**

**TEAM #14**

This project entailed the structural analysis and design of a 44-person dormitory and a 6-8 person family-style house, as shown in Figures 2 and 3. The elements included in the design were the trusses, slab, vertical and horizontal reinforcement, and foundation design. The final deliverables of the project included complete structural construction documents for each building, a detailed report outlining the design procedure, a preliminary cost estimate of the structural portion of the buildings, and three-dimensional renderings to be used for fundraising purposes.

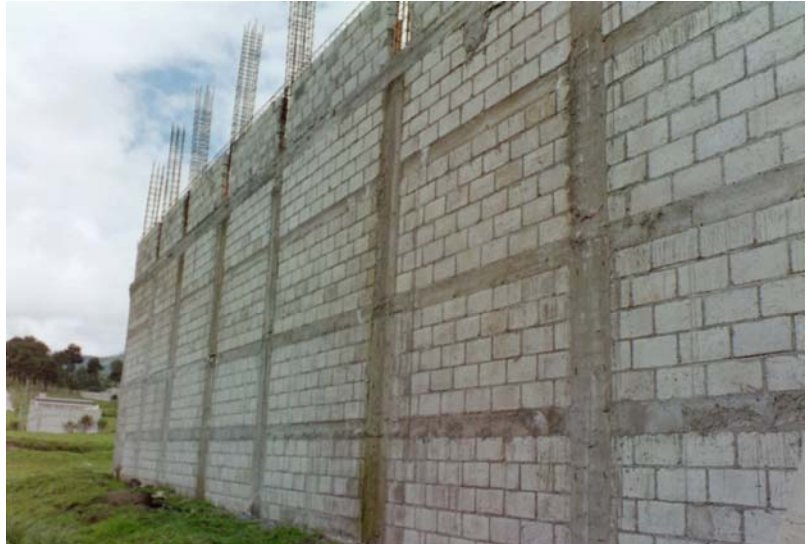
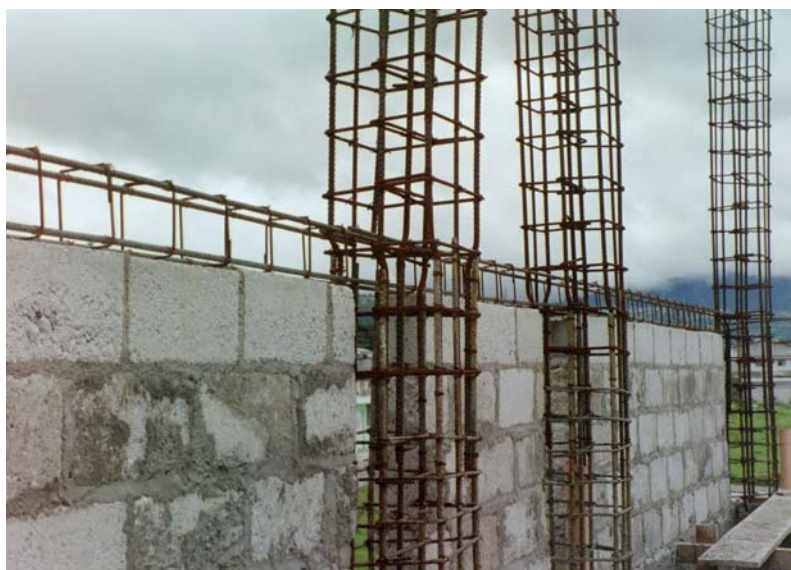
**Figure 4: Vertical and Horizontal Reinforcing**

This can be seen in Figures 4 and 5. These wall reinforcements consist of a cage of rebar made up of usually four bigger bars running the full length, either vertically or horizontally, with ties every 6 to 12 inches. As the building goes up, concrete is poured around the cage to create, in effect, a rigid frame. The reinforcement is typically placed every 4 to 8 feet, for two reasons. First, their concrete masonry

block does not have the load bearing capacity that is characteristic of American block as mentioned above. And secondly, this rigid frame resists earthquake shear forces by helping the building move as a single unit instead of each floor moving separately. In keeping with the culture, this method of construction was employed in the design of these buildings.

construction techniques. In Guatemala it is typical to use a grid of vertical and horizontal wall reinforcement instead of typical American steel columns.

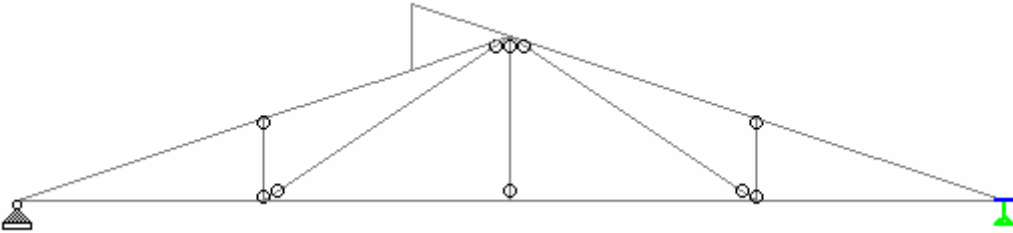
Figure 6. Truss 1 (Small Group Cabin)

Figures 6 through 8 below show the three different truss designs that were originally developed.

The truss in Figure 6 was unable to support the calculated load, while the truss in Figure 7 was over designed. The truss in Figure 8 supported the calculated load according to output from STAAD.Pro. However, it did not have interior members at the supports. This was problematic because the truss had no vertical component to take the load at the support point, which would have resulted in bending along the bottom chord.

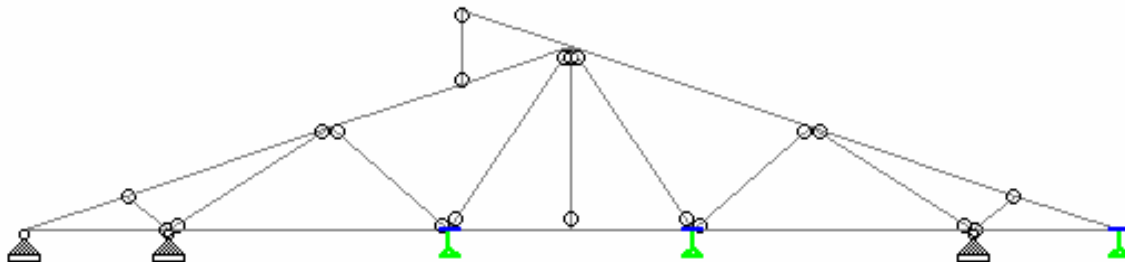
**Figure 9. Truss 4 (Small Group Cabin)**

In the end, Truss 4 in Figure 9 was chosen as the final design.

This truss has been modified to include internal members at the supports. In addition, the truss can sustain the calculated load and is also economically feasible. Calculations verifying that this truss functions appropriately are shown in Appendix B. The top and bottom chords are 3 in. x 3 in. x  $\frac{1}{4}$  in. double angle members and the interior members are 2 in. x 2 in. x  $\frac{1}{8}$  in. double angles.

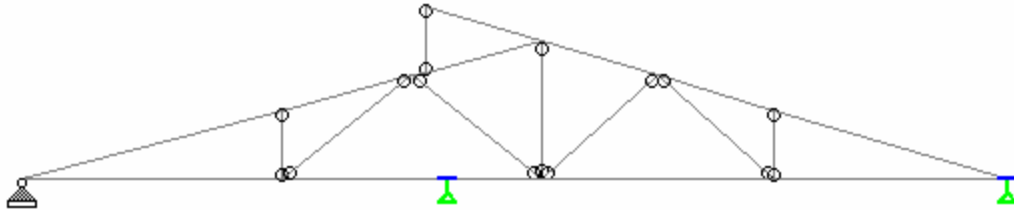
**Figure 10. Truss 5 (Casita)**

Truss 5, as seen in Figure 10, was the original design for the long truss on this building.

This truss, though, had no members at the internal support, which would have caused bending in the bottom chord. In addition, it did not line up with the wall appropriately, which resulted in an incorrect slope along the top chords.

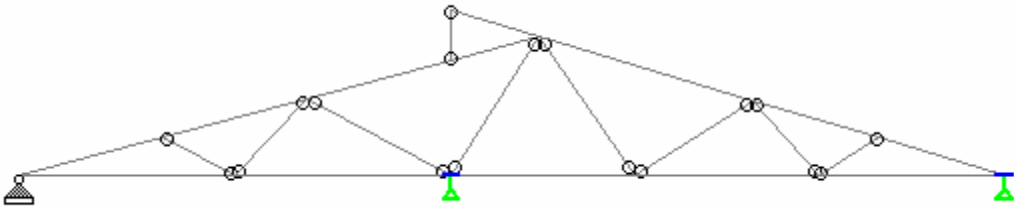
**Figure 11. Truss 6: Final Design (Casita)**

Truss 6 on Figure 11 was chosen as the final design.

This truss does have members at the internal support and is capable of withstanding the calculated load. Results and calculations for this truss analysis are shown in Appendix B. The top and bottom chords are 2 in. x 2 in. x  $\frac{1}{4}$  in. double angle members and the interior members are 2 in. x 2 in. x  $\frac{1}{8}$  in. double angles.

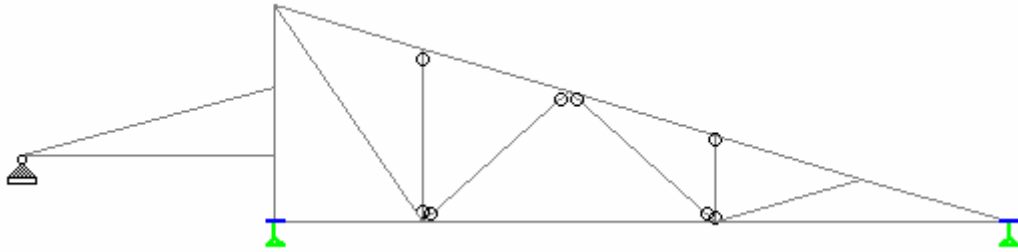
Figure 12. Truss 7 (Casita)

Truss 7 on Figure 12 was originally designed to be the short truss for this building. This truss, though, had an incorrect slope and needed to be re-designed.

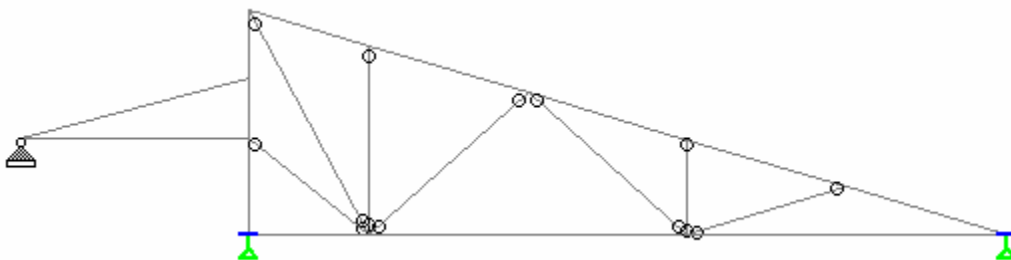
Figure 13. Truss 8: Final Design (Casita)

Truss 8 on Figure 13 was chosen as the final design.

This truss has the correct slope and lines up appropriately with the two exterior walls. Calculations justifying this truss design can be seen in Appendix B. The top and bottom chords are 2 in. x 2 in. x  $\frac{1}{4}$  in. double angle members and the interior members are 2 in. x 2 in. x  $\frac{1}{8}$  in. double angles. These members were also designed to match the members on the long truss.

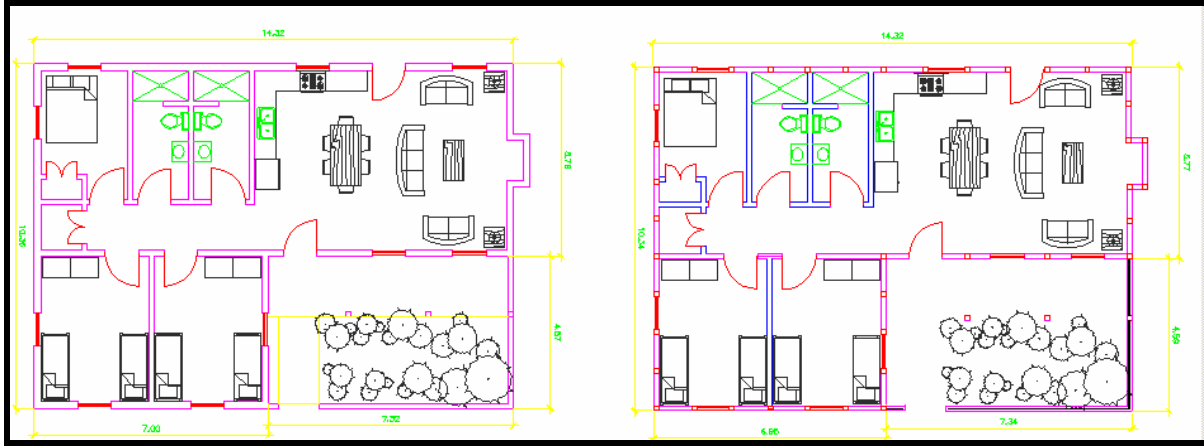
**Figure 15. Existing and Proposed Layout for Casita**

Placing columns approximately every 4 feet also affected the layout of the casita, which was adjusted as seen in Figure 15.

After submitting the original design to Randy Larsen, he stated that the reinforcement could be placed either at four feet or at a greater distance. During the original phone conversation, his remark about reinforcement was interpreted as a stringent maximum requirement. However, Randy Larsen later clarified that four feet was a general guideline for the Guatemalan area. He also stated that it would be more economical to only place vertical and horizontal reinforcement along windows and doors. In the end, we chose this latter arrangement as part of our design. This also kept the original floor layout design for the small group cabin valid. Having square 15 cm by 15 cm horizontal and vertical reinforcement still worked with this new design since the reinforcement had been slightly oversized originally. Consequently, 15 cm by 15 cm vertical and horizontal reinforcement were placed along the windows and doors of both buildings.
